# UNDERWATER BRIDGE INSPECTION REPORT

STRUCTURE NO. 18506

RABBIT LAKE

PREPARED FOR THE  
MINNESOTA DEPARTMENT OF TRANSPORTATION  
BY  
COLLINS ENGINEERS, INC.  
JOB NO. 5221

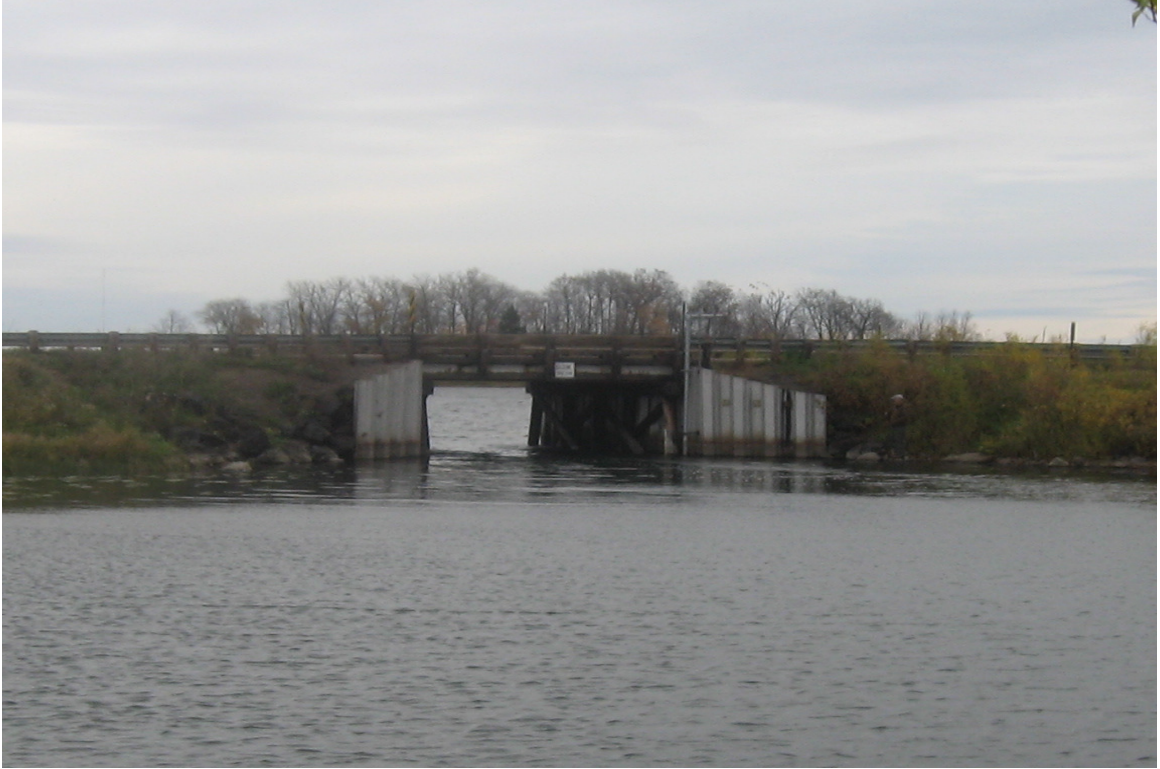
Photograph 1. Overall View of the Structure, Looking East.

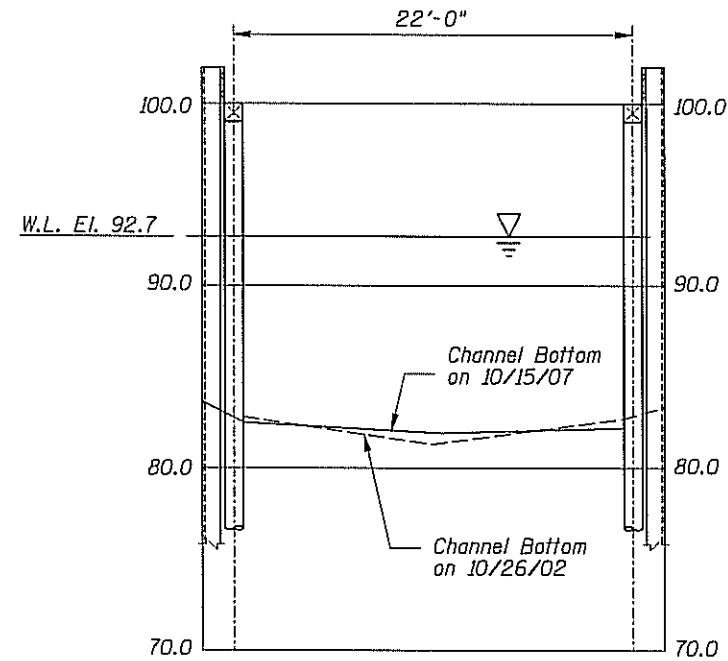
UPSTREAM FASCIA PROFILE

1. The channel bottom consisted of silty sand with 2 to 4 inches of probe rod penetration.
2. The timber members exhibited very minor checking up to 1/8 inch wide.
3. Light aquatic growth was observed on the steel sheeting below the waterline.
4. The steel sheeting exhibited coating failure and surface corrosion on 50 to 100 percent of the surface area from 2 feet above to 6 inches below the waterline with minor delaminations and section loss of up to 1/32 inch in depth. From 6 inches below the waterline to the channel bottom, the steel sheeting exhibited rust nodules with up to 1/16-inch-deep pitting on less than 5 percent of the surface area.
